Anaerobic Digestion at Morrisville State College: Internal Combustion Engine Teardown and Evaluation

A Case Study By
Mr. Ronald Alexander and Dr. Walid Shayya,
Morrisville State College

Based on Engine Analysis by
Ronald Alexander, Automotive Department
Chair, Morrisville State College

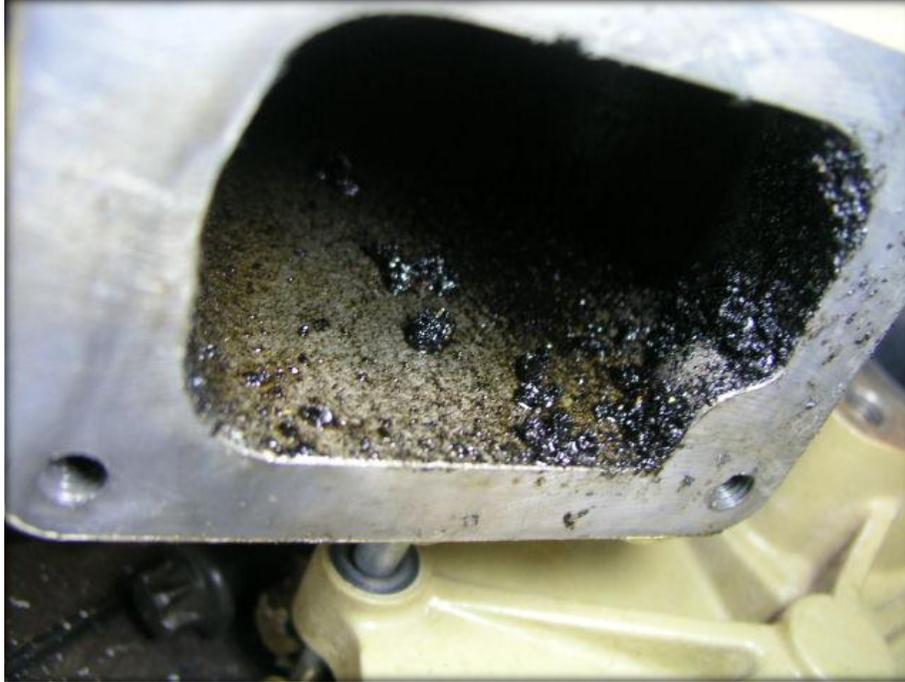
All manifolds gasket surfaces and bolt torque seemed normal for an engine of this type and no signs of leakage or corrosion of gasket material were found. The exhaust manifold looked normal with no signs of overheating or discoloration. Normal exhausts carbon build-up was observed in the exhaust ports and runners. Intake gasket was free of corrosion and seemed intact. However, excessive amounts of black greasy carbon deposits were observed in the main intake runner and were found on the walls of each intake runner up to the intake port of each cylinder. This could be due to the type of fuel being used. Deposits on intake runners are normal in internal combustion engines but this was above the

normal levels indicating a potential problem that could result in engine mechanical damage such as sticking valves resulting in compression loss. Excessive carbon can also result in engine piston deposits that could increase compression and reduce efficacy. Engine damage can result from large amounts of carbon ingested during the normal engine cycle resulting in internal combustion engine damage.

View of the black greasy carbon deposits observed in the main intake runner.

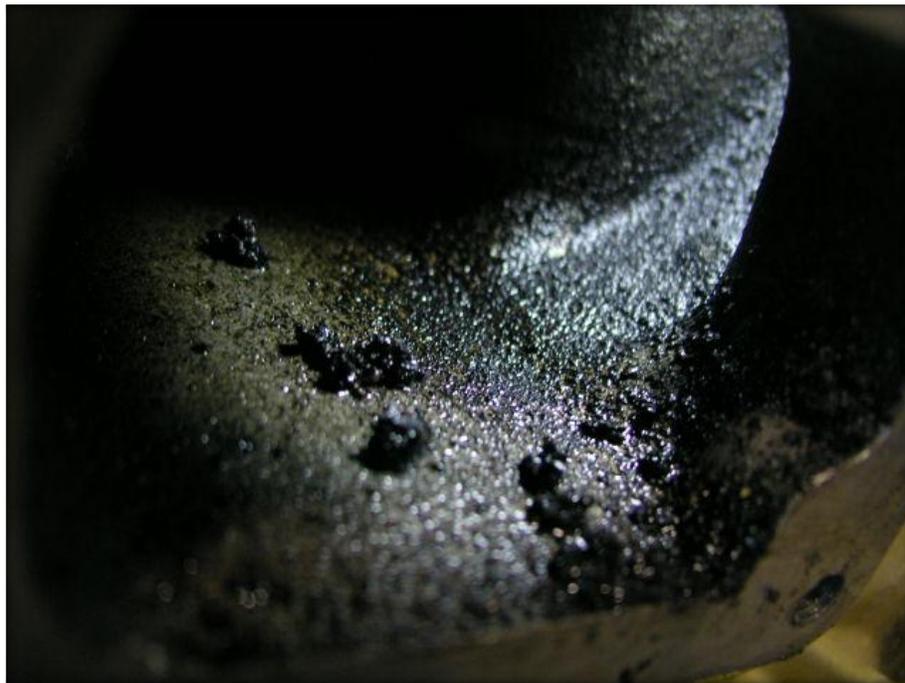
Another image of the heavy intake deposits.

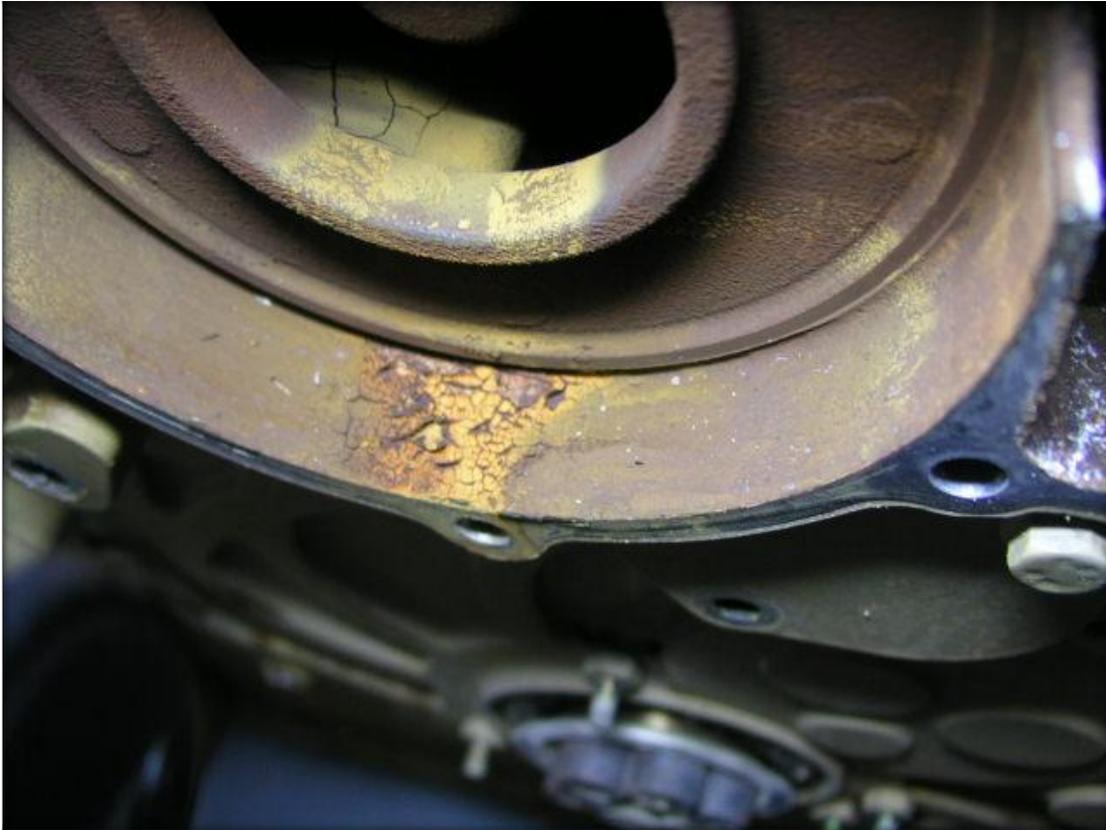
The water pump assembly was removed from the front of the engine. The gasket surface was found normal with only light corrosion and no leaks. The internal engine coolant passage was found to have rust and corrosion, an indication of lack of corrosion protectors in the coolant. Water was found to be the main coolant and was not mixed with any other product. This could over time, result in internal engine component damage resulting in coolant loss and overheating. Radiator passages could also plug resulting in engine overheat.

View of the coolant passage of the water pump showing rust and corrosion.

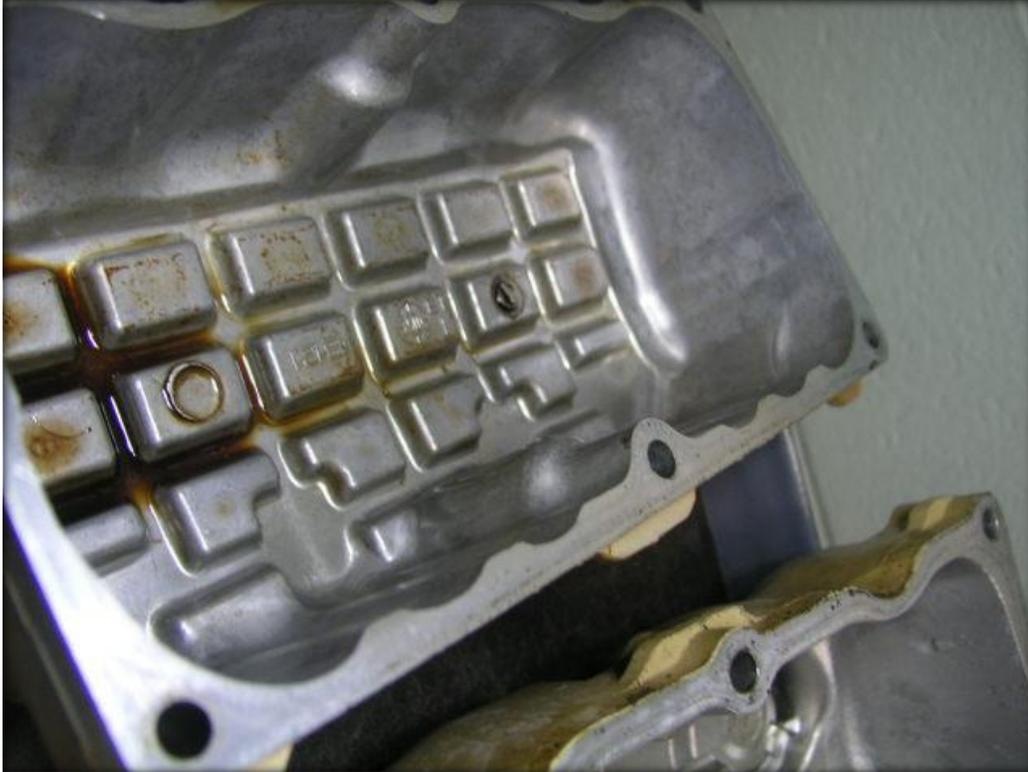
Picture showing clean valve cover and internal engine components.

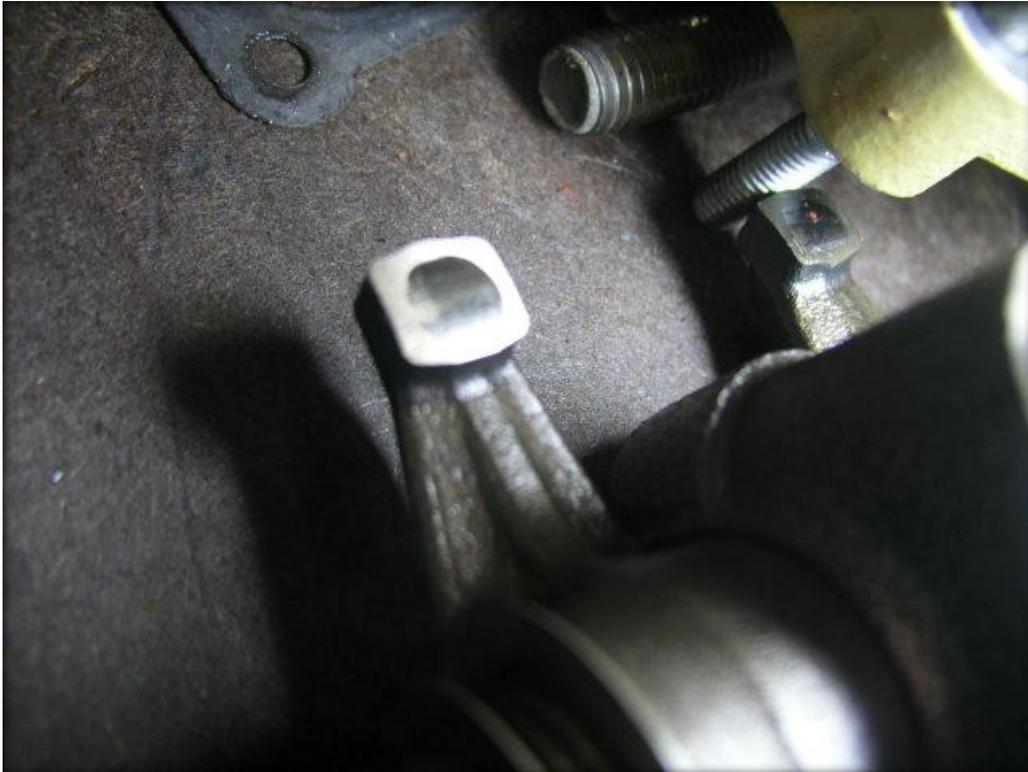
Image showing very light wear on rocker arm pivot.

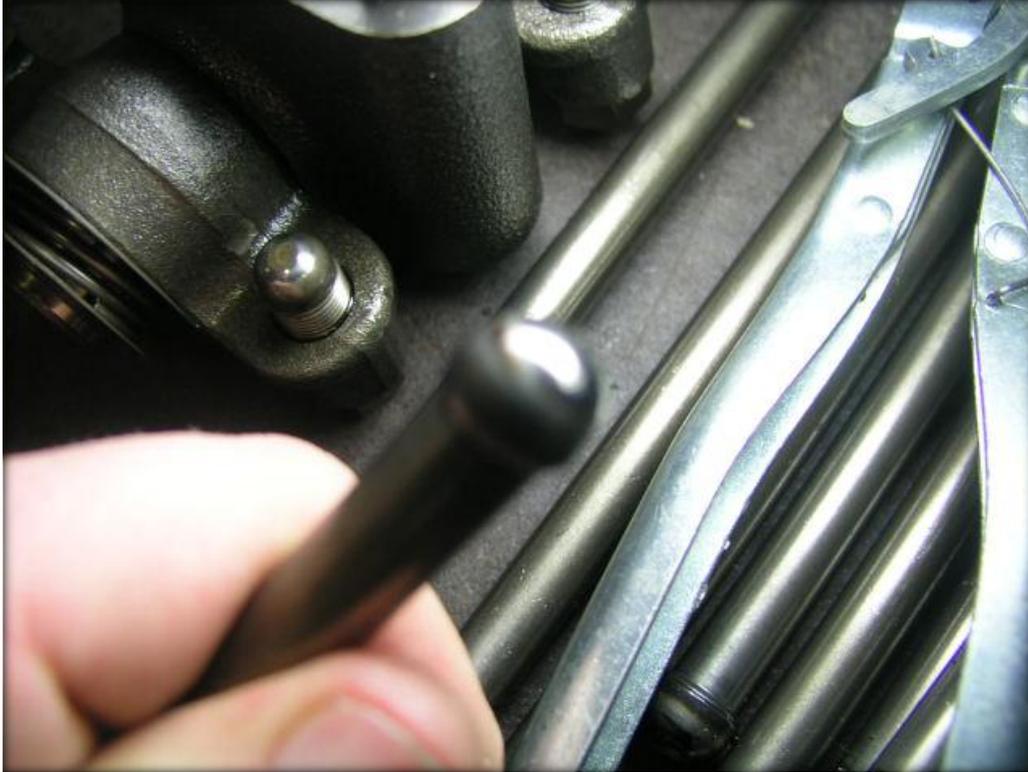
Image showing no excessive wear on any valve train related parts.

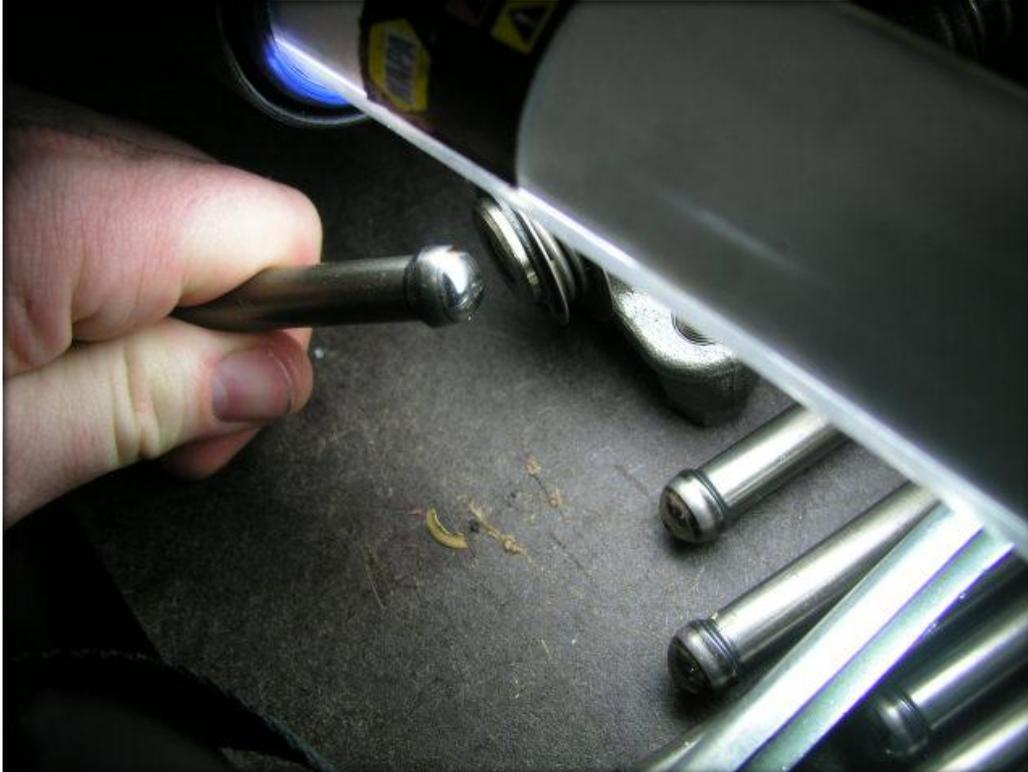
Another view of pushrod pivot showing very little wear.

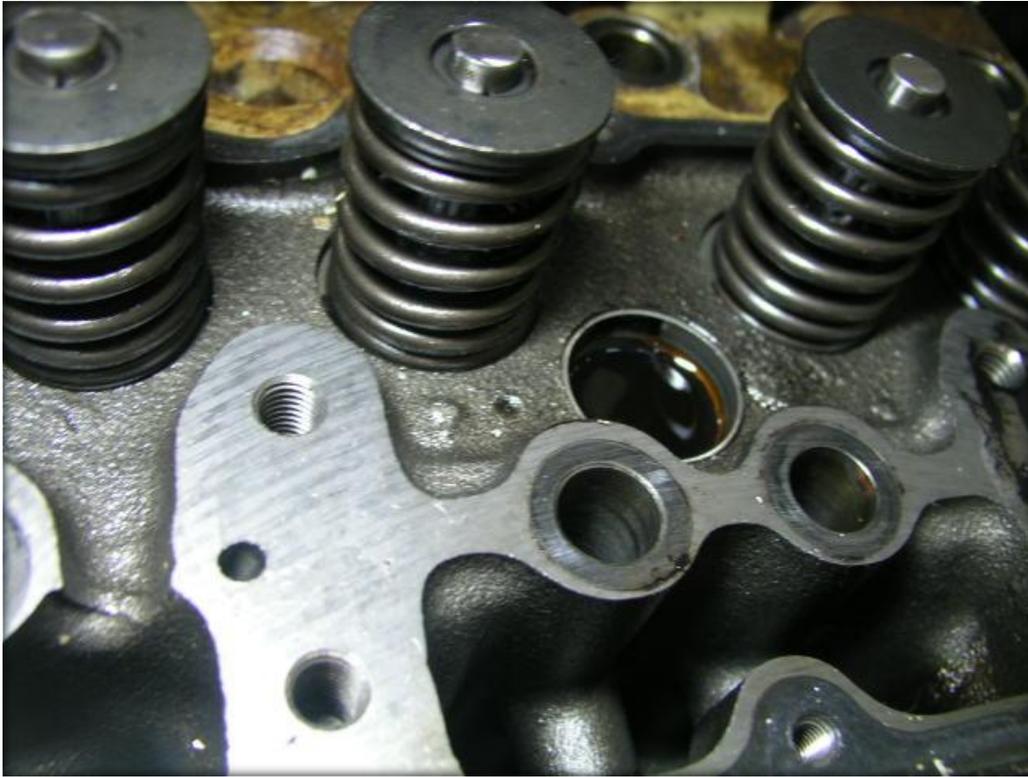
A picture of the cylinder head assembly showing no internal engine oil deposits or sludge build-up.

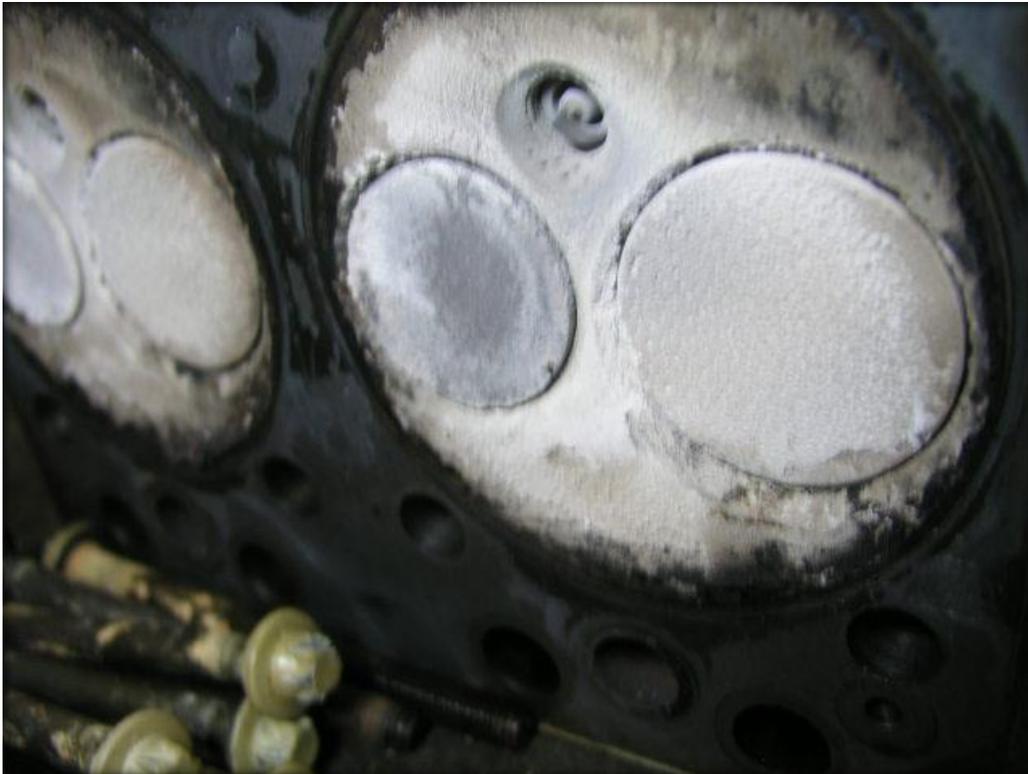
A view of the carbon deposits observed on valve faces.

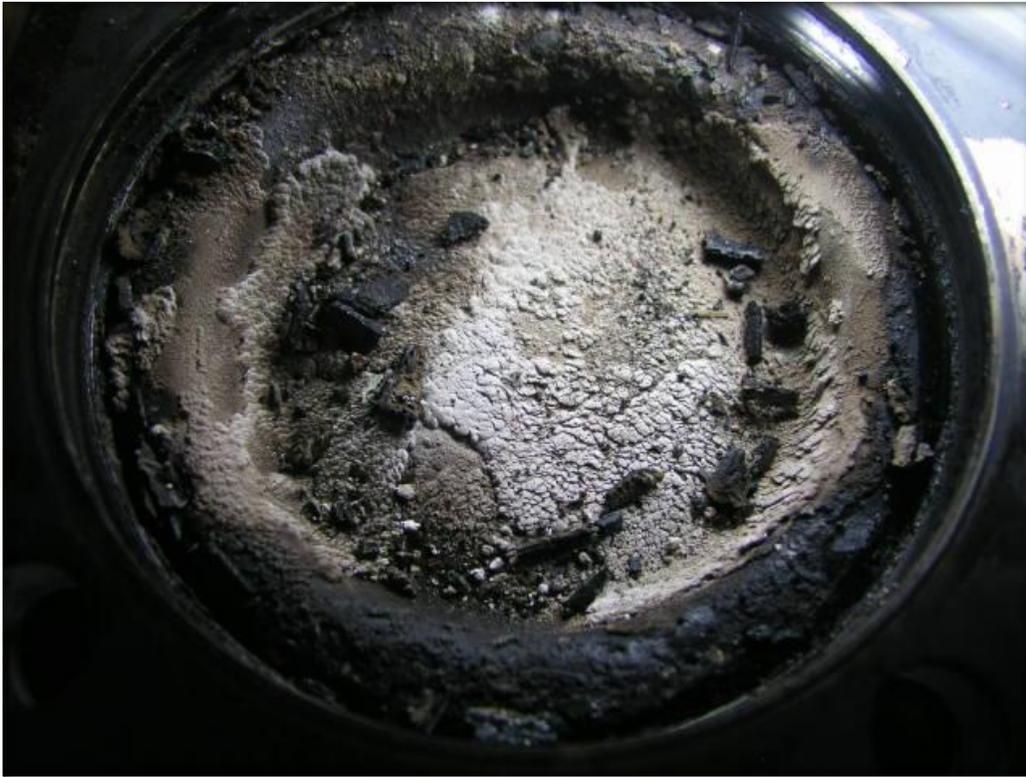
Heavy white deposits were observed on all piston faces, including some having large pieces flaking off that could be a potential for mechanical failure. Deposits could be contributed to fuel usage or lower engine operating temperatures.

A view of the heavy white deposits observed on the faces of all pistons.

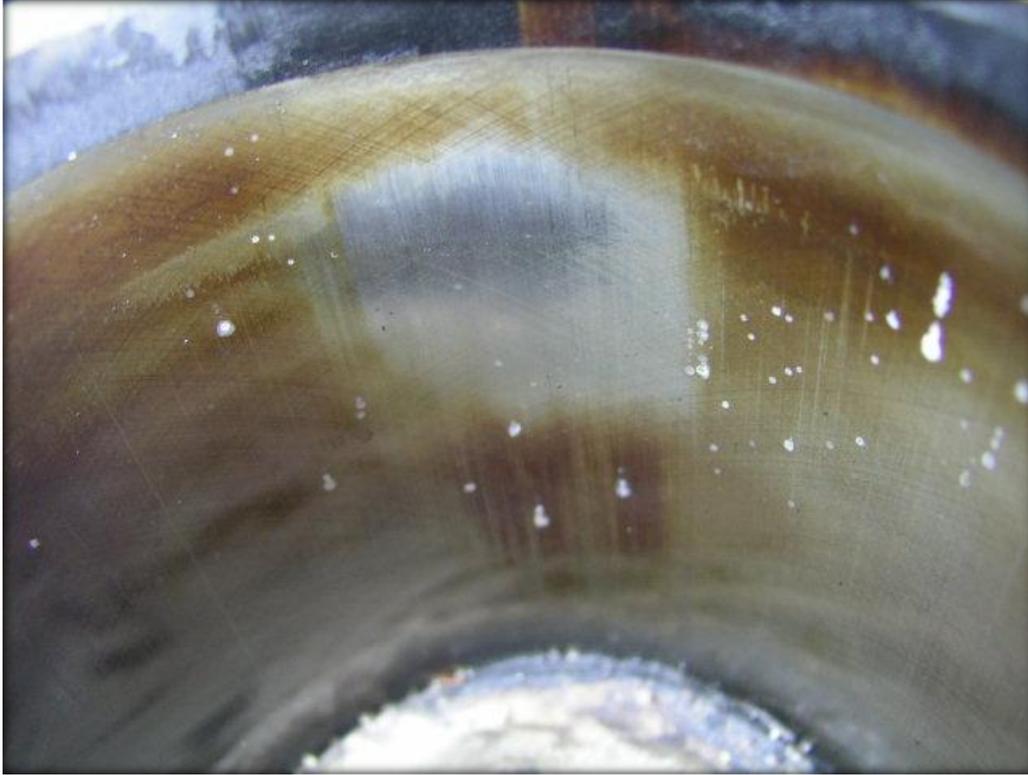
Glazing oil deposits on cylinder walls showing some oil burning during combustion suggest possible oil ring failure. This type of oil glazing is normal for an engine operating for this many hours (the factory cross hatch machine pattern is still visible indicating very minimum wear on cylinder walls). A large carbon ridge was found above ring travel at the top of the cylinder bore but no cylinder wear ridge was found, indicating that the cylinders require minimal machine work for re-service.

Overall, no excessive cylinder wall wear was observed but some vertical scratches were found on cylinder walls which could be due to hard carbon dragging above the number one compression ring. This is due to large amounts of carbon buildup on piston land surface above the compression rings (light engine machining would be required to repair this condition). The cylinder walls were straight and free of excessive taper and out of round (no cracks or abnormal wear was observed and the condition of all parts are considered serviceable). The cylinder decks and head surfaces were flat and free of warping and cracking. As such, no machine work will be required for re-service.

A typical view of the cylinder walls.

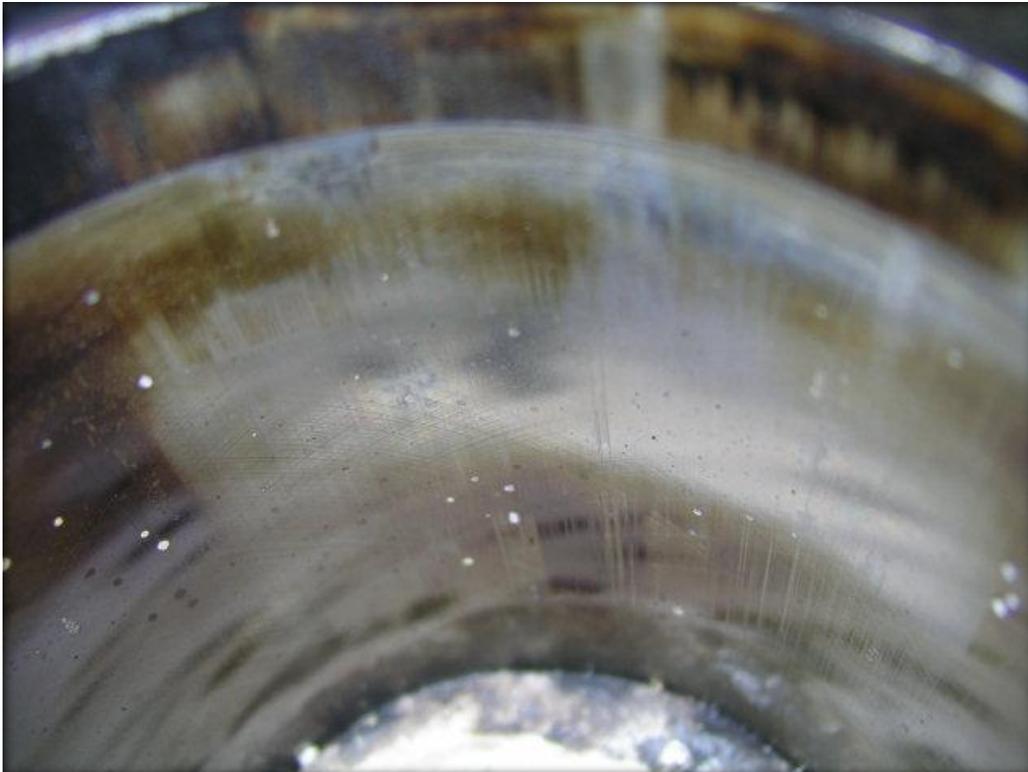
The clean patch shown in picture was wiped clean to see cross hatch.
