Anaerobic Digestion at Morrisville State College: A Case Study

**Dr. Walid H. Shayya, School of Agriculture, Sustainability,
Business, and Entrepreneurship, Morrisville State College**

Created: July 27, 2008

Last Revised: August 12, 2013

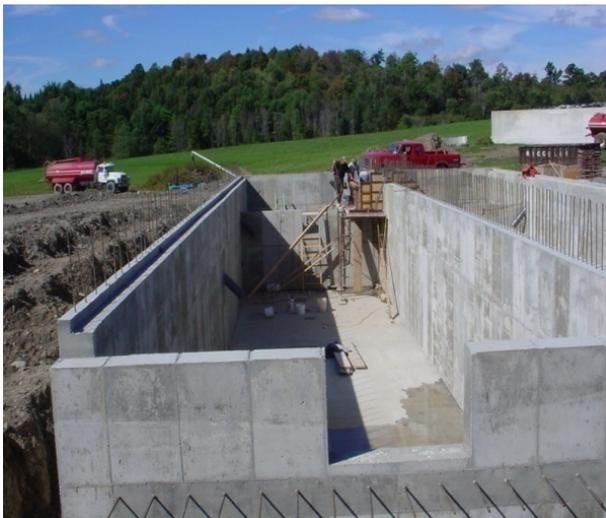
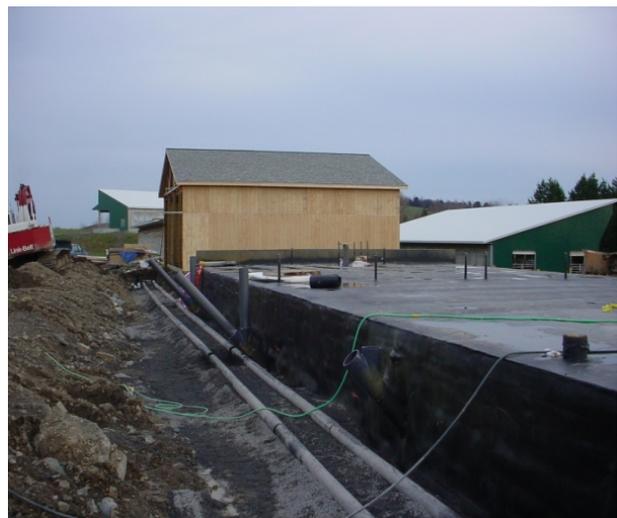
The plug-flow, hard-top digester at MSC is a rectangular, in-ground concrete tank consisting of two sides (north and south) separated by a concrete wall. Each of the two sides of the digester include another wall that separates the digester tank from a smaller grit chamber where the primary heat exchangers are located for heating the influent waste stream. The bigger chamber on each side of the digester includes a smaller heat exchanger (a heat maintenance loop) to maintain the temperature at an optimum mesophilic condition of about 98°F. The hard-top of the digester is constructed of flat pre-cast concrete planks covered with concrete, insulation, and earth. The digester is covered on the inside with a coating of coal tar epoxy, a layer of polyurethane, and a coating of poly-urea (applied to the ceiling of the digester as well as the inside walls of both chambers to a level of about a couple of feet below the liquid line in the tank) in order to provide a biogas-tight tank. It is insulated on the outside with a layer of polyurethane (to maintain temperature) and a coating of poly-urea (to protect the insulation from UV light damage during construction). The design allows for a maximum of 15" of water column pressure to be developed within each of the two sides of the digester. This precludes the need to compress the biogas before feeding to the internal combustion engine.

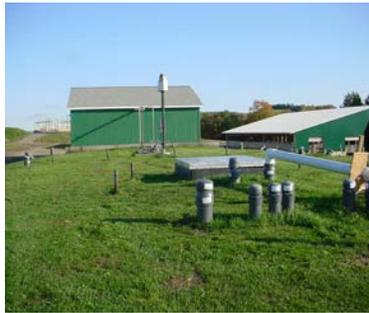
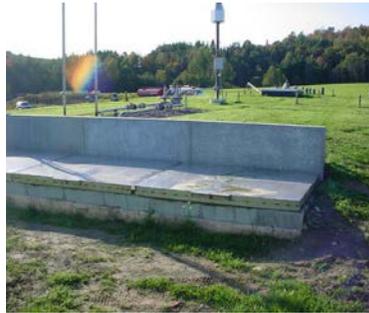
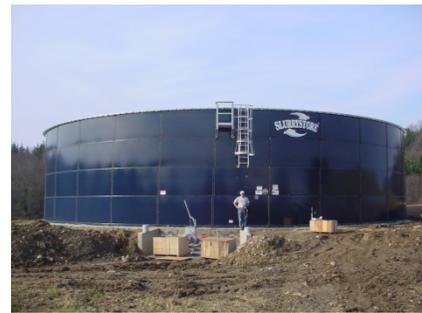
As manure is displaced in the two sides of the digester, it flows to the effluent chamber where it gets conveyed to the effluent compartment of the manure reception pit before being pumped to long-term storage or loaded onto a tanker for spreading on agricultural fields.

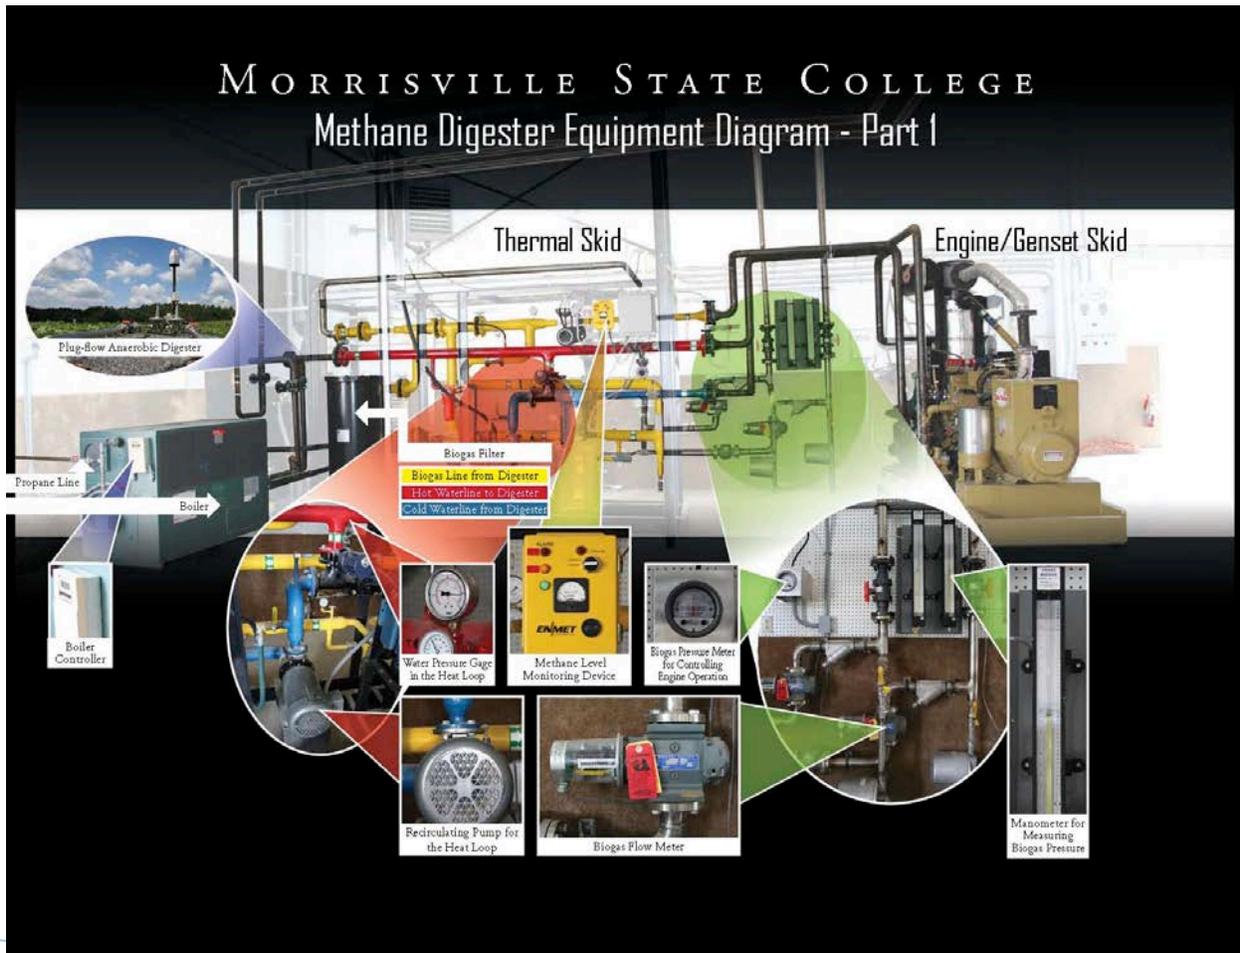
Biogas is collected from the two sides of the digester and fed to an internal combustion engine (ICE) located in the equipment (or CHP) building. The engine (MAN) is attached to a 50-kW generator. Hot water from the engine is not only used to maintain the digester temperature but also heat a nearby system that is being used to conduct applied research on growing algae for biodiesel production. A radiator located outside the equipment building is used to release the excess heat. A 300,000-Btu/hr output boiler system is installed within the CHP to be used to heat the digester during the startup phase

or when the ICE is down. The boiler was acquired from Performance Engineering Group of Livonia, MI, as a research donation. Stainless steel biogas lines connect the gas chambers within the two sides of the digester to the CHP building. Finally, a flare system is installed to burn excess biogas or the generated biogas when the ICE is down (the flare mount and gas line supports are located on the top of the digester's concrete tank).
