Anaerobic Digestion at Morrisville State College: Internal Combustion Engine Teardown and Evaluation

A Case Study By
Mr. Ronald Alexander and Dr. Walid Shayya,
Morrisville State College

Based on Engine Analysis by
Ronald Alexander, Automotive Department
Chair, Morrisville State College

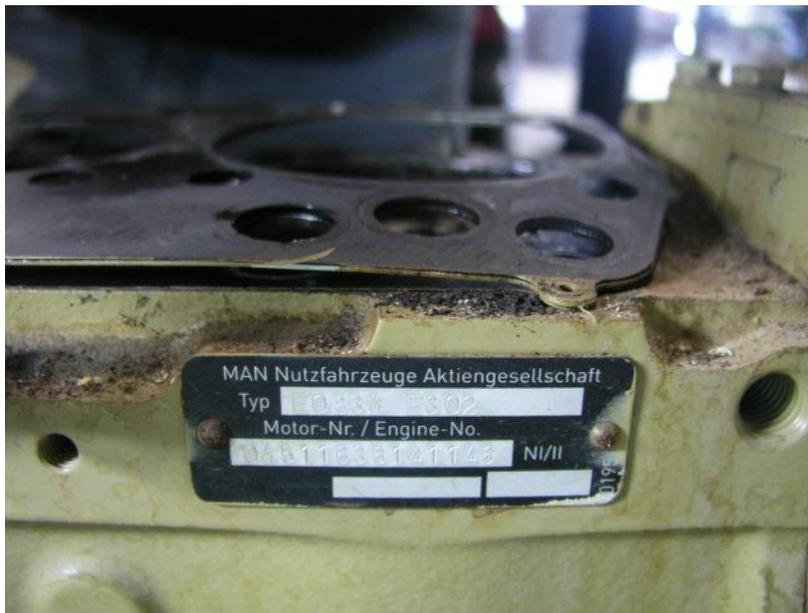
Visual inspection found the external engine case to be sound and free from oil and coolant leaks with no signs of overheating. The engine did not have low oil pressure and was running normally at the time of removal. No compression test was conducted prior to removal but the engine was running normally with no complaints of loss of power or misfiring.
